Economic Feasibility Study & Historic Structures Report

De Pere Lockkeeper's House Government Island De Pere, Wisconsin

Jennifer L. Lehrke, AIA, LEED AP LJM Architects, Inc. 813 Riverfront Drive Sheboygan, Wisconsin 53081

September 2011

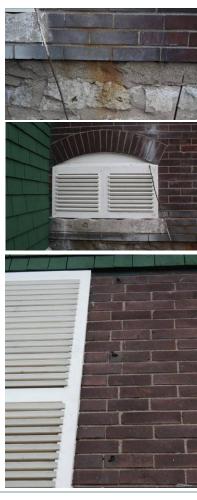
The above grade walls are comprised of red brick and grey mortar, with the exception of the walls of the Back Porch which are green painted wood shingles. All of the wall materials are in good condition as a result of the 2010 stabilization project. Several corrective measures were identified:

- Remove rust stains and miscellaneous paint splatter from brick west of the Back Porch.
- Repair or replace chipped and spalling stone sill at basement window west of the Back Porch.
- Remove paint splatter from stone sill at Kitchen window west of the Back Porch.

- Remove three metal brackets and screws along the west side of the Kitchen window west of the Back Porch and repair masonry.
- Remove miscellaneous paint splatter from brick east of the Back Porch.
- Remove paint splatter from stone sill or repaint stone sill at Dining Room window east of the Back Porch.
