# Preconstruction Conditions

# Final Bank Stabilization

September 18<sup>th</sup>, 2009

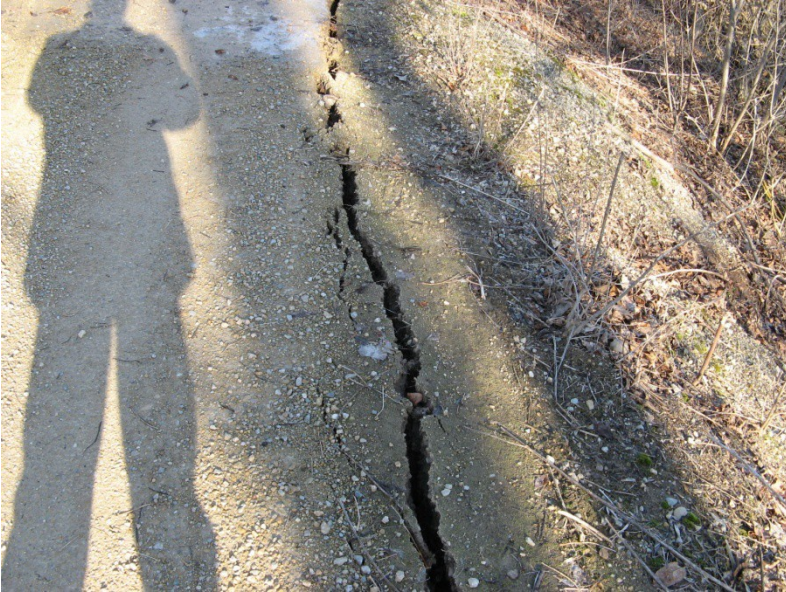
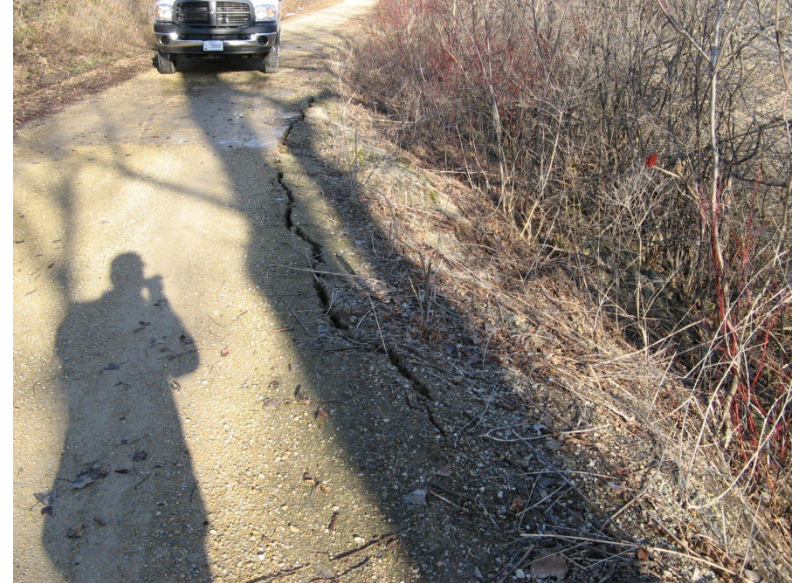
Slope showing stabilization problems

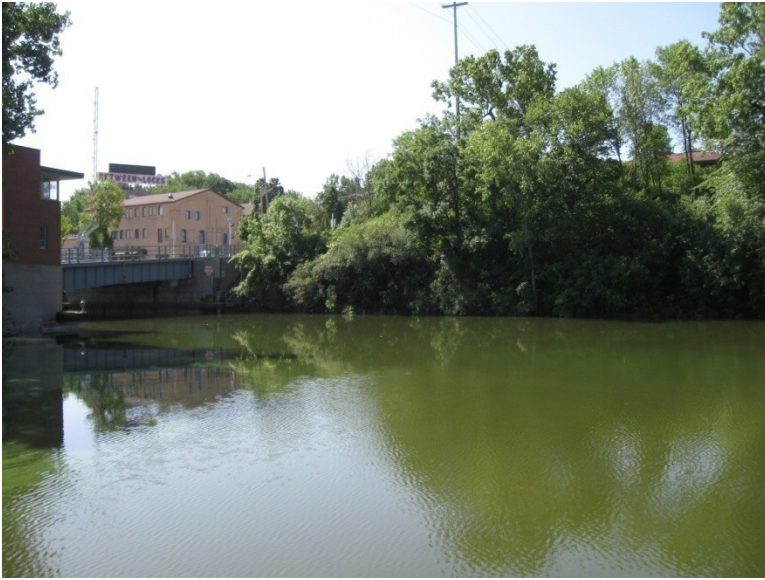
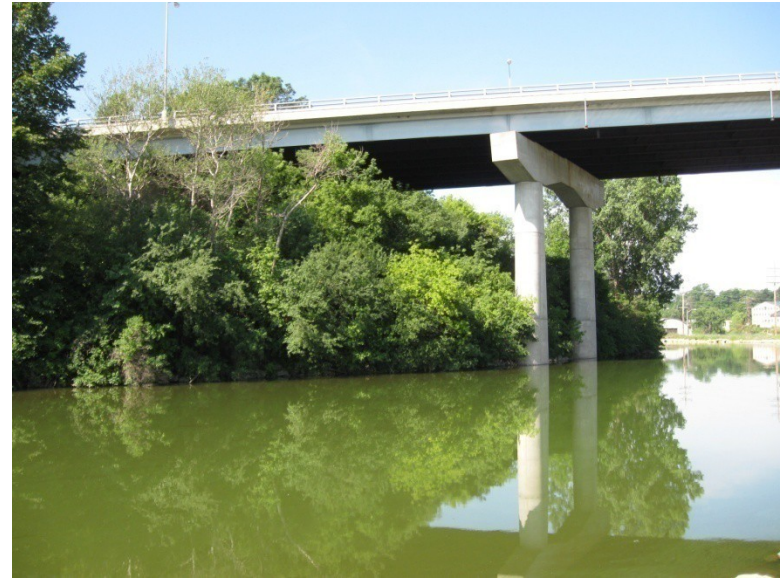
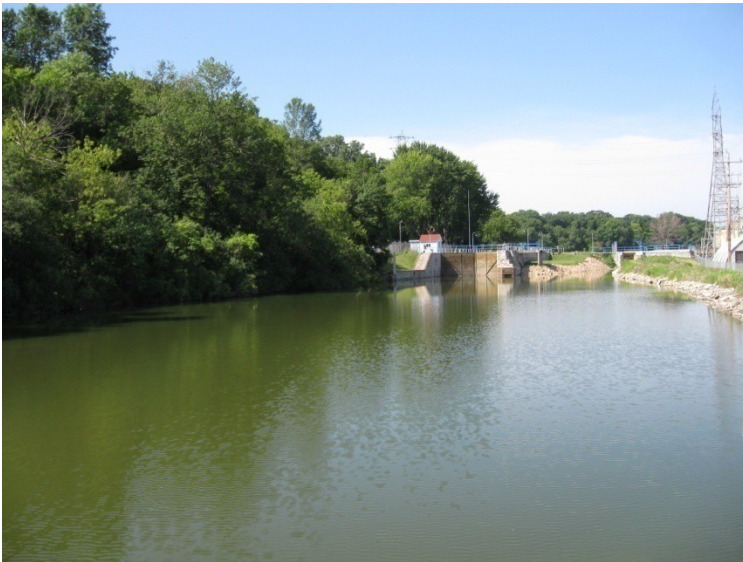
Overgrown slope

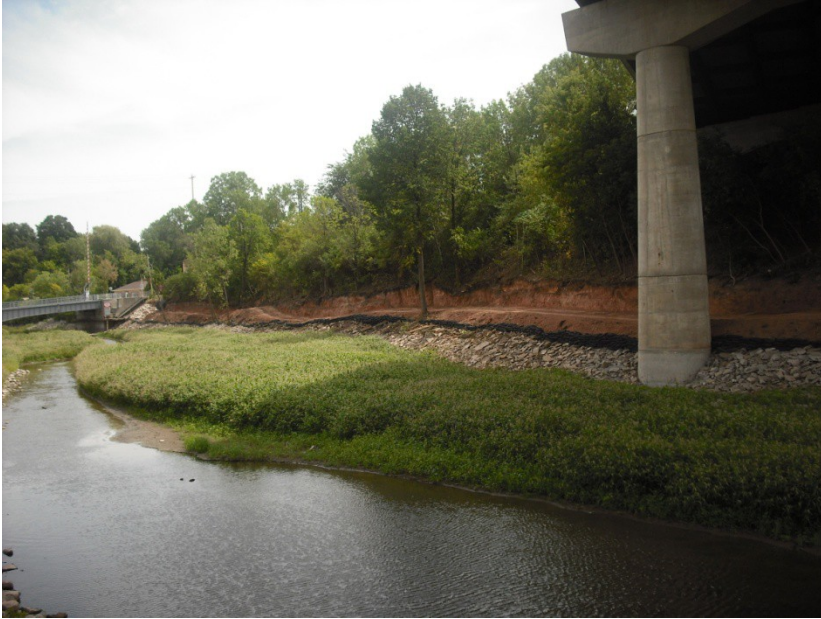
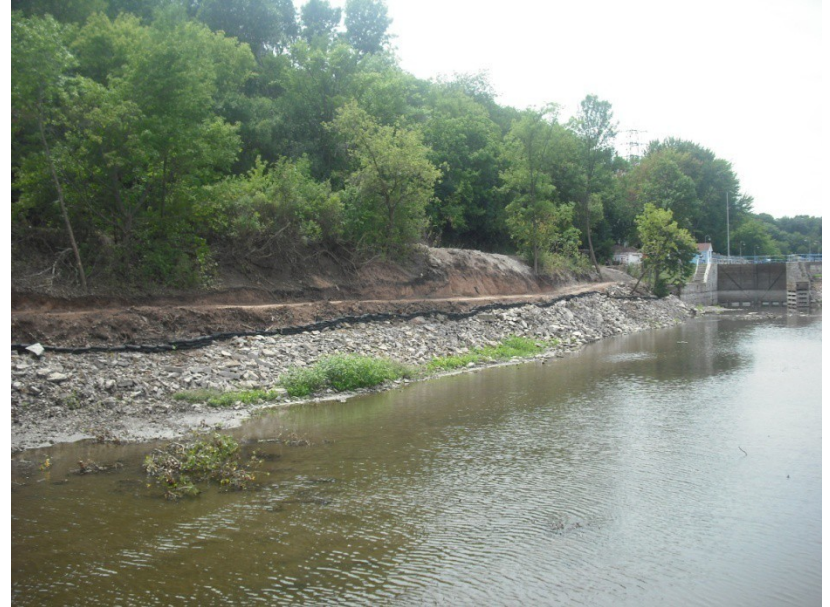
Clearing of trees and brush

Bench cut into slope for construction access

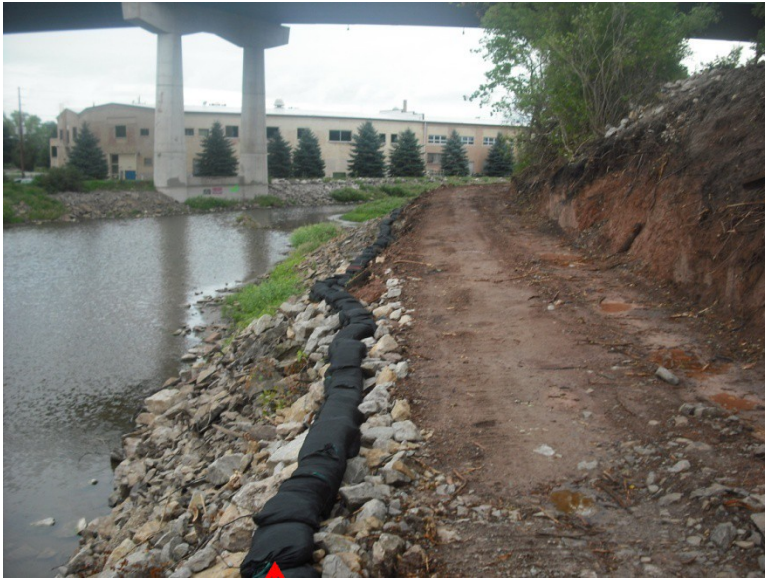
Bench cut looking east

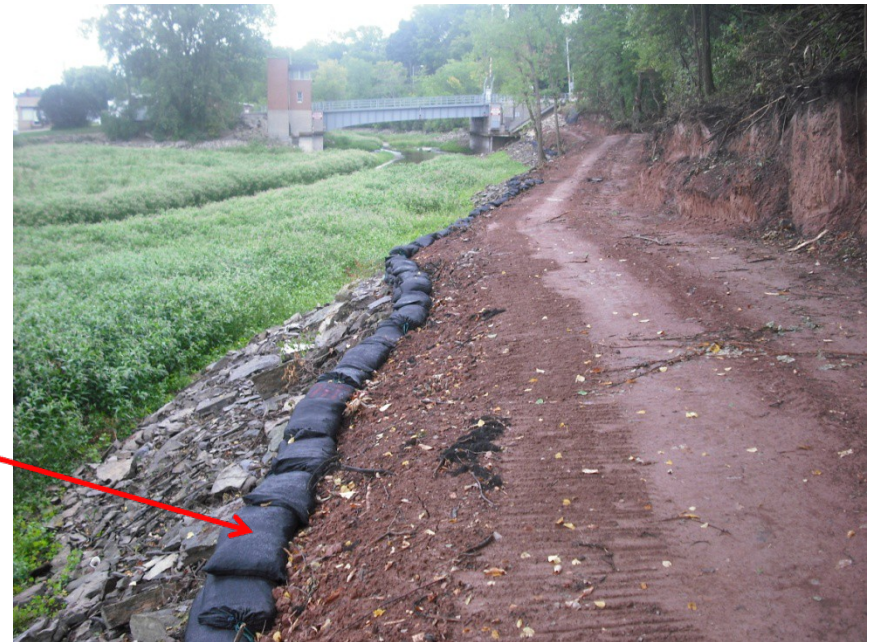
Rock Filter Bags used for  
Erosion Control

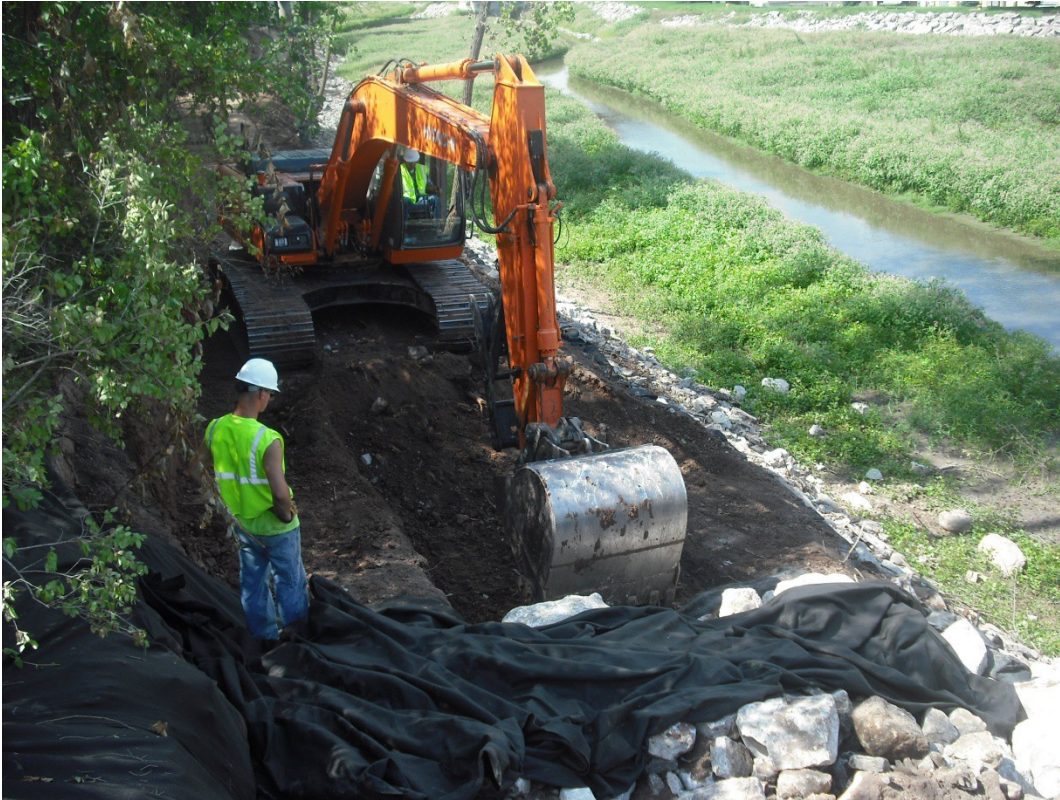
- After access road was cut, excavation was still needed down to final elevation for rip rap placement.
- Geotextile fabric was placed on bare soil and rip rap was placed on top.

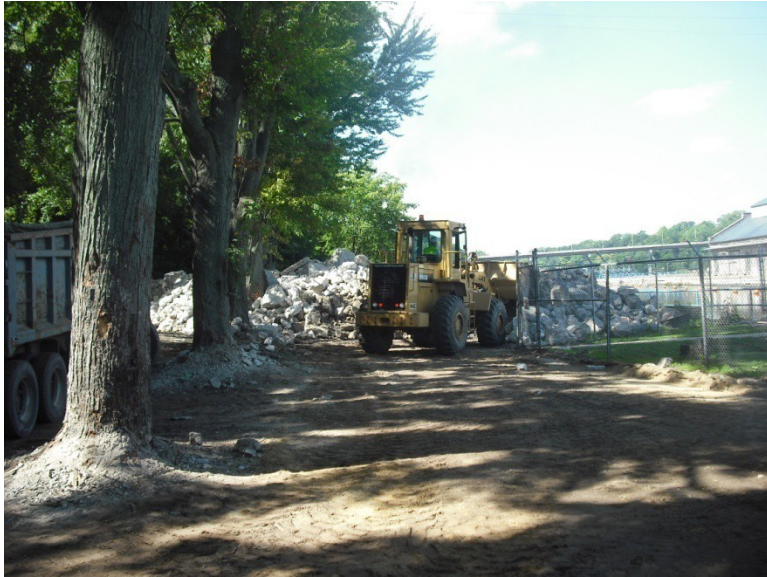
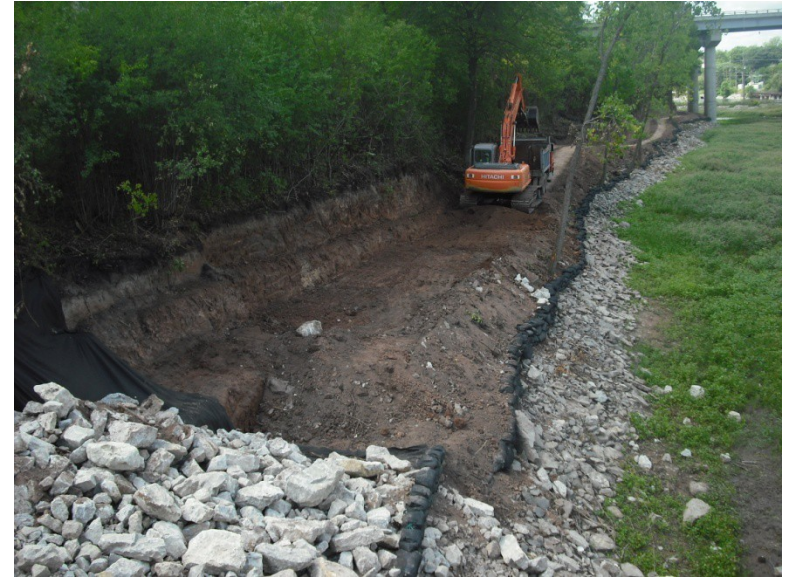
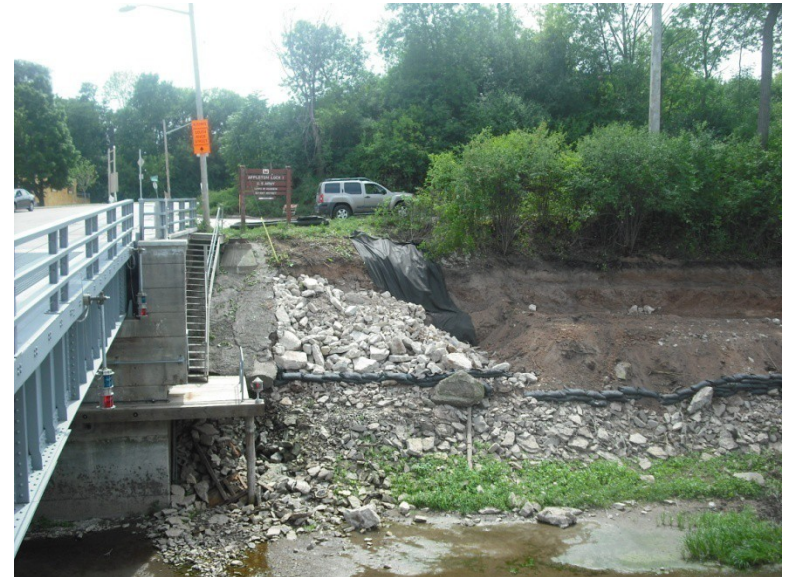
Rip rap stockpile  
& placement

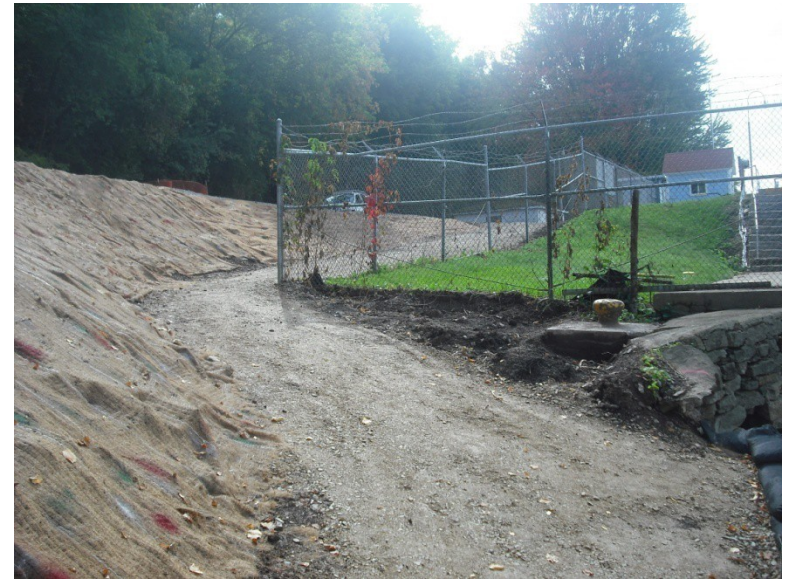
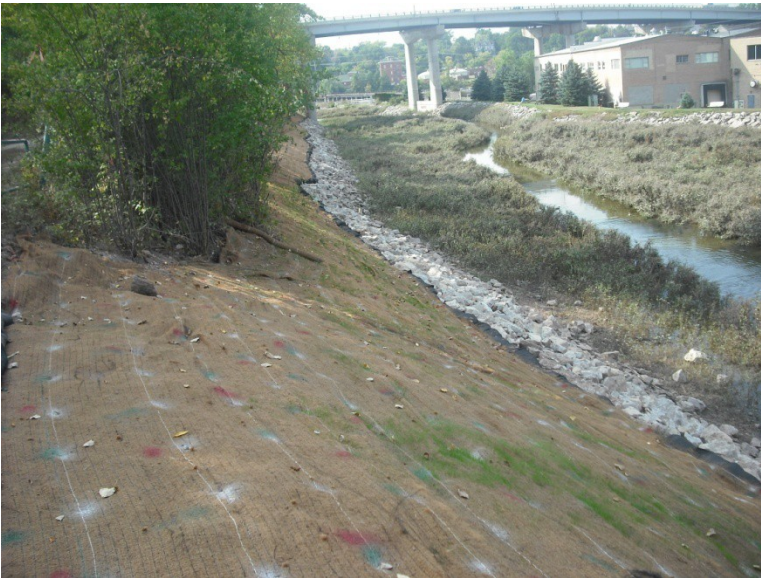
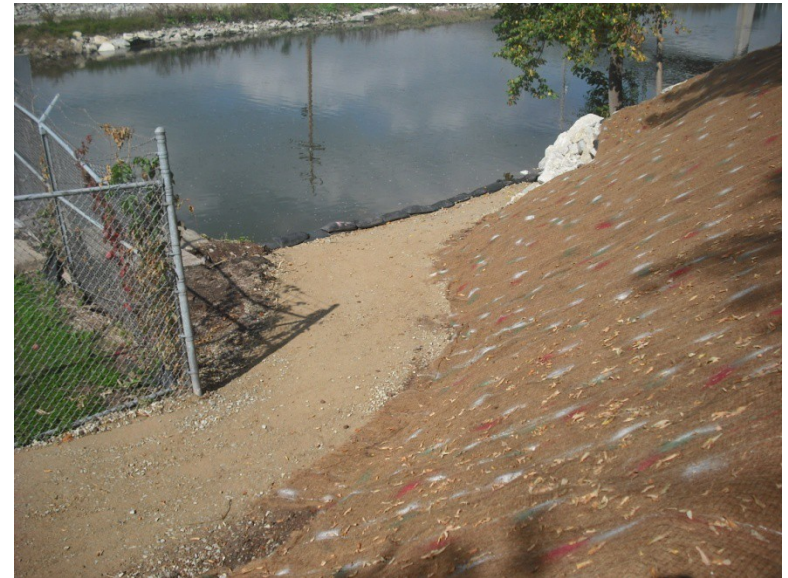
- Erosion Mat placement
- Canoe /Kayak Access
- Vegetation growing

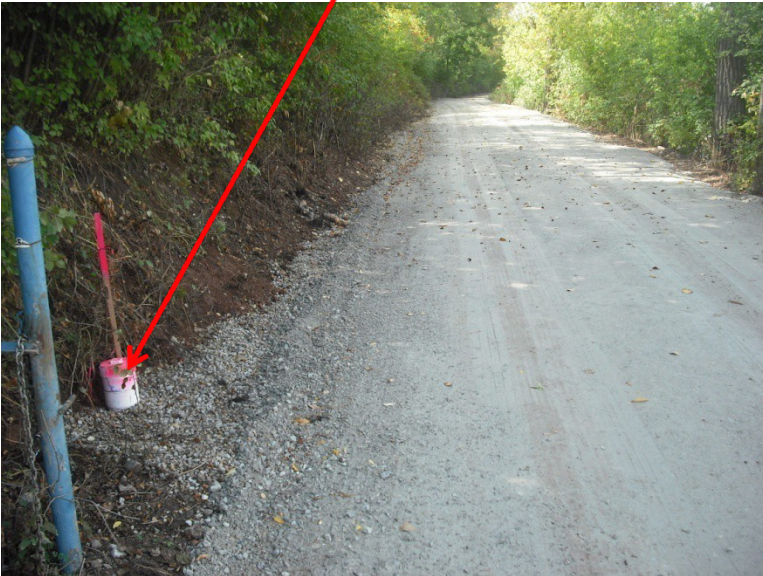
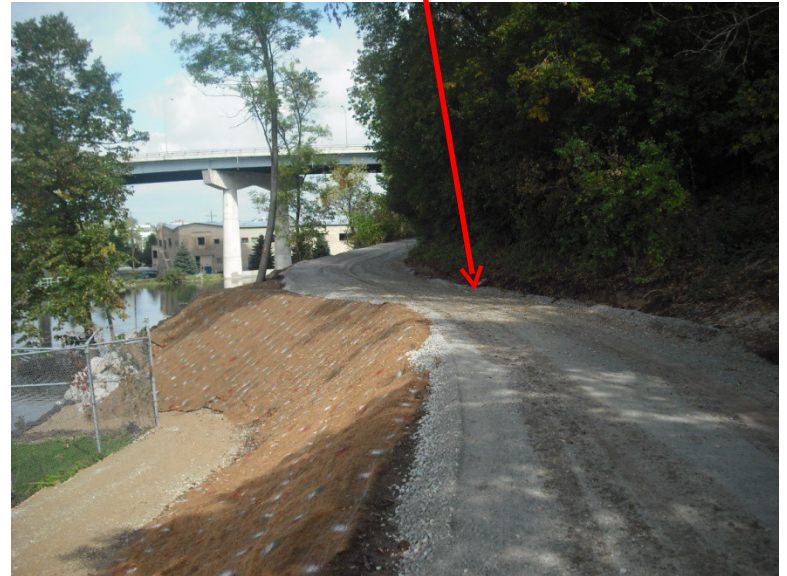
Access road graded to pitch back to drain tile

Drain tile installed along upslope side
